# Comparison of Aerial Robotic Vs. Manual Ultrasonic Testing on Elevated Carbon Steel Plates

Jamie L. Branch, P.E. Corrosion Engineer

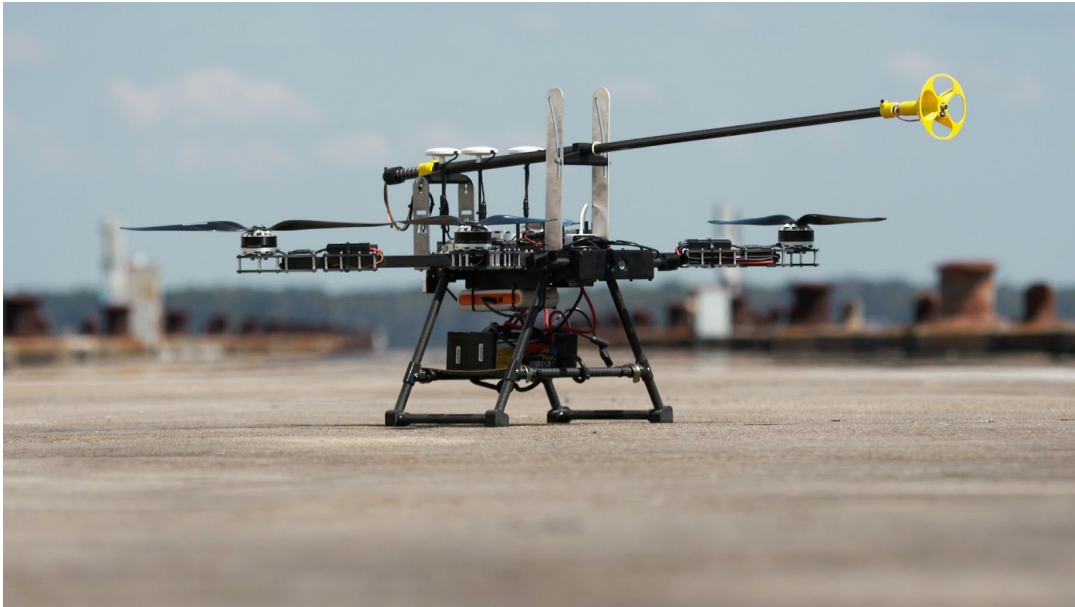
The aerial robotic system used to perform measurements is a hardened custom drone equipped with an array of sensor systems, a full computer, and custom software to allow automatic flight to contact wall structures for measurements. The aircraft also has a robotic arm with an end effector (hand), which is the component that physically contacts the material being tested. The end effector contains the UT measurement probe and an integrated couplant dispenser. Lastly, the aircraft was powered by two 6-cell lithium polymer rechargeable batteries. While the aircraft is able to operate on ground-based “shore power,” that option was not utilized for this study.

**Figure 1:** Apellix NDT Aerial Robot

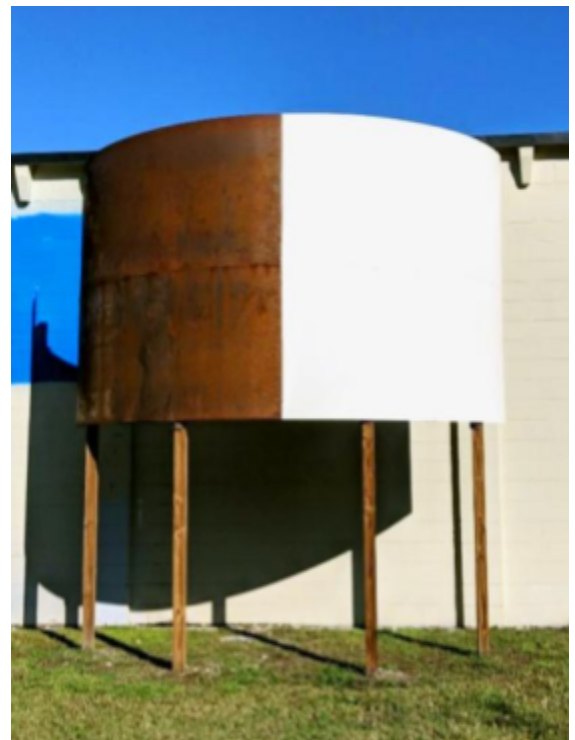
Two carbon steel plates were elevated to mimic a storage tank (see Figure 2). One plate was left uncoated and exposed to the natural

**Figure 2:** Coated and Uncoated Elevated Carbon Steel Test Plates

environment. The second plate was surface prepped with a wire brush and simple green solvent and then coated with Sherwin Williams MACROPOXY 646-100 fast-cure epoxy base coat, and Sherwin Williams Hi-Solids Polyurethane top coat. The finished coating system had a dry film thickness (DFT) of 7-10 mils. To limit the inspection test area, the corners of a 3ft-by-3ft square were lightly marked on each plate as the allowable measurement area. The measurement area started at 12 feet and ended at 15 feet from ground level. Only measurements obtained in these squares were included in this study.

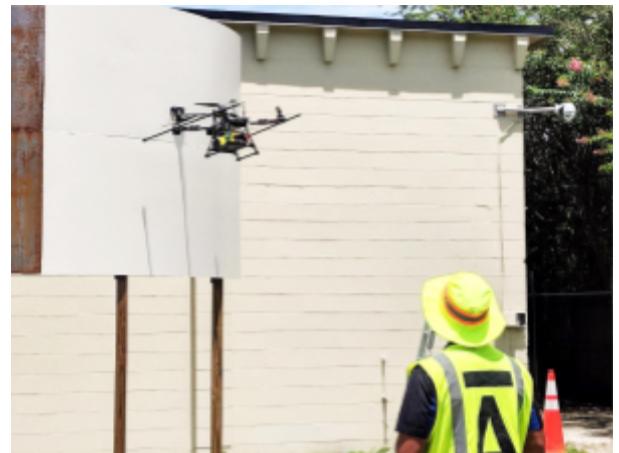
**Figure 3:** Pilot taking measurements on coated side

The results shown below include the environmental data from the days the UT readings were collected, as well as information on the calibration of both the UT handheld electronic device used by the NDT engineer and the one utilized by the aerial robotic system. The UT data for the thickness of the steel plates is also shown. Total flight time for measuring the uncoated and coated side was approximately 15 minutes each, including battery changes. Figure 3 captures the pilot taking a measurement on the coated side.
