# The Feasibility of Ultrasonic (UT) Material Thickness Readings of an Aboveground Storage Tank Using an Aerial Robotic System (Drone)

Jamie Branch, Corrosion Engineer at Apellix

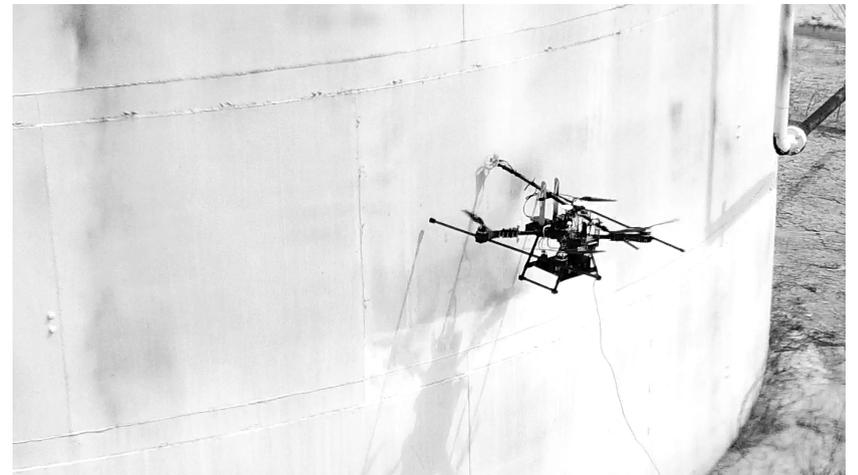
**Figure 1:** Aerial Robotic System Performing UT Reading on Tank Wall

The aerial robotic system used to perform measurements is a hardened custom drone equipped with an array of sensor systems, a full computer, and custom software to allow automatic flight to contact wall structures for measurements. The aircraft also has a robotic arm with an end effector, which is the component that physically contacts the material being tested. The end effector contains the UT measurement probe and an integrated couplant dispenser. Lastly, the aircraft was powered by two 6 cell lithium polymer rechargeable batteries.

As a reference measurement, a certified API 653 tank inspector, working for the facility and asset owner, measured one wall thickness reading at arm's height (approximately 5ft) to be 0.219 inches using an Olympus 38DL PLUS. The pilot navigated the aircraft to ten separate random locations at various heights and locations along the Southwest side of the tank. Under autonomous control, the pilot had the aerial system fly in and touch the tank wall to collect a UT reading. The first five of ten thickness reading attempts were unsuccessful due to too short of interface between the probe tip and material surface. After the unsuccessful attempts were recognized, the pilot adjusted flight such that the aircraft would hold contact on the material surface for a longer
